**TYPICAL  
Schedule of Condition**

**Premises**

Recorded by Cresswell Property Surveys  
Chartered Surveyors, Building & Structural Consultants  
01530 – 563444 or 563636

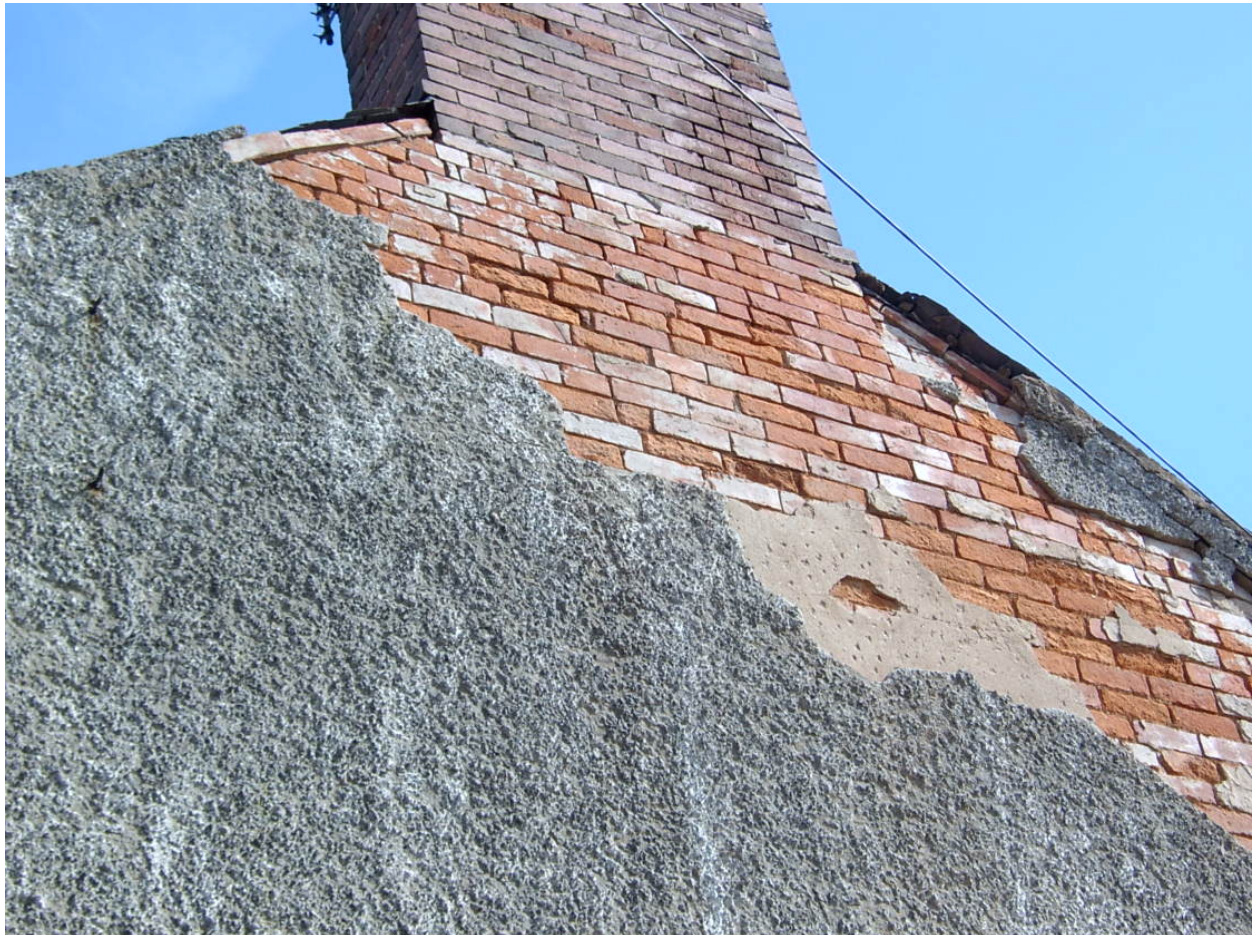
**Photo 1** – Here we would describe the condition of the structural element.

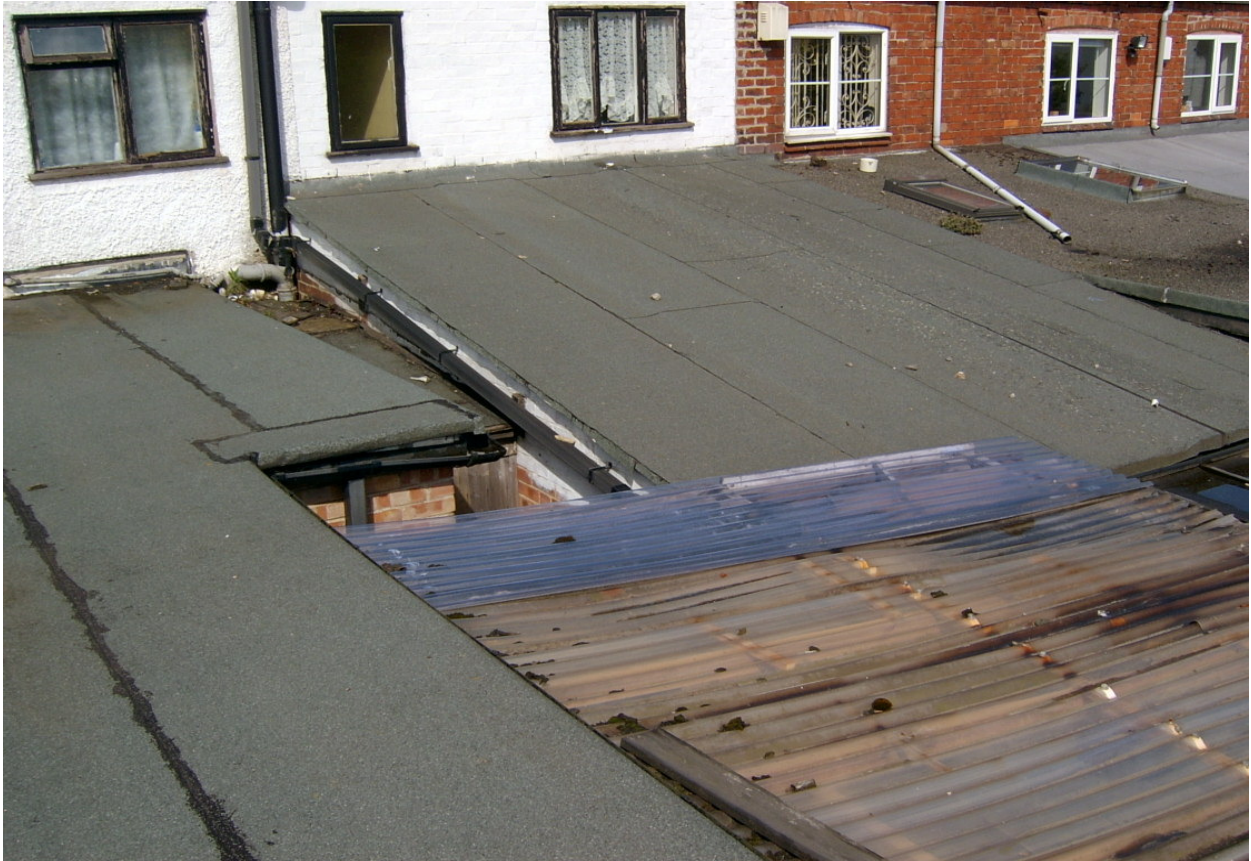
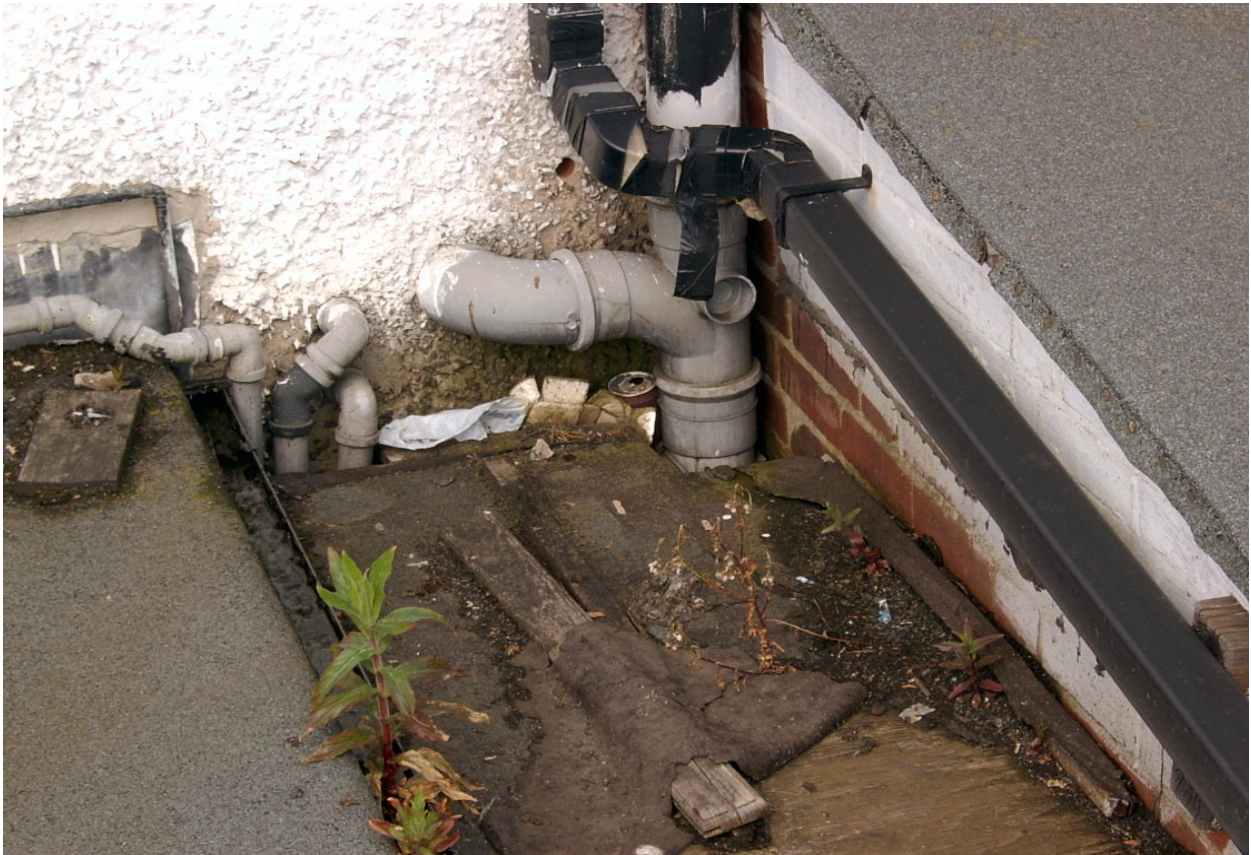
**Photos 2 & 3** – Here we would describe the condition of the structural elements.
